DoD Corrosion Prevention and Control Program (CPC)

Demonstration and Validation of Corrosion- Mitigation Technologies for Mechanical Room Utility Piping and Cooling-Tower Pumps

Final Report on Project F07-ARCTC01

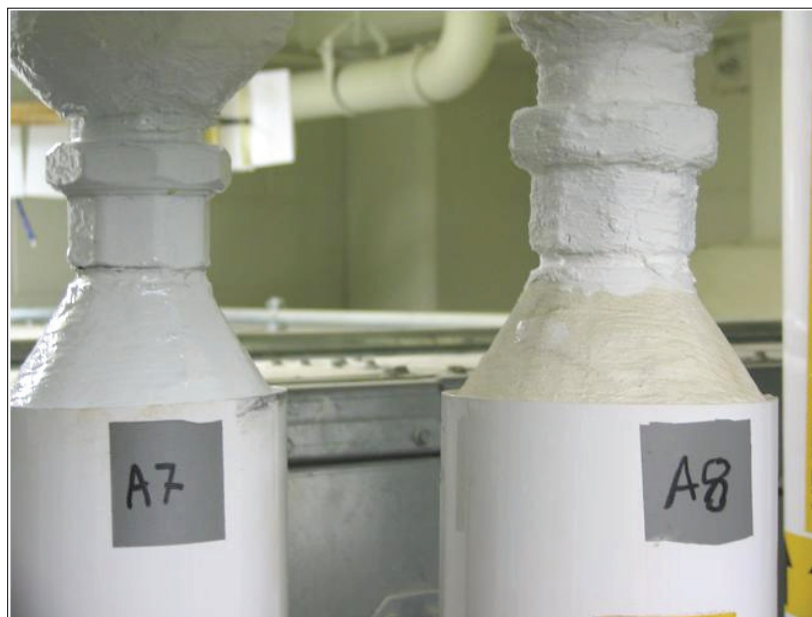
Figure 3. Union joints in Mechanical Room A, coated with Sherwin-Williams Corothane System (A7, on left) and TC Ceramic (A8, on right).

application consisted of wiping and coating small areas in order to maintain a dry substrate. The following day, thickness measurements were taken from all painted items. Measurements ranged from 1.6 to 5.0 mils, with most in the 2.0–3.0 mil range. Selected items were dried with a cloth and then coated with Sherwin-Williams Corothane I Aliphatic (white) topcoat. Final thickness measurements on these items ranged from 5.0–8.0 mils, with most in the 5.0–6.0 mil range. The remaining primed items were brush-coated with Capstone TC Ceramic. Due to the high viscosity of the product, the initial coat went on very rough, and a second coat was deemed necessary. The second coat was applied after a 3 hour dry time and produced a more acceptable coating appearance. Final system thickness ranged from 30–80 mils, with most measurements in the 30–40 mil range. Two coated fittings, one with the Sherwin-Williams Corothane system and one with TC Ceramic, are shown in Figure 3.

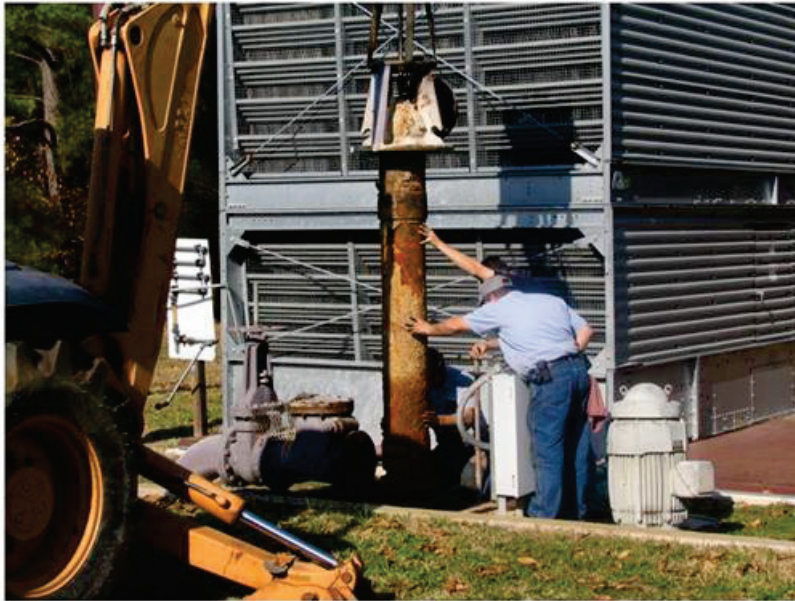
Figure 5. Pump 3 being removed from sump.

In December 2007 the three demonstration pumps were removed. The column and bowl sections of all three pumps were found to be heavily corroded. The internal mechanisms did not show any corrosion, however. The condition of each pump at the time of its removal is presented in Figure 5 through Figure 8.

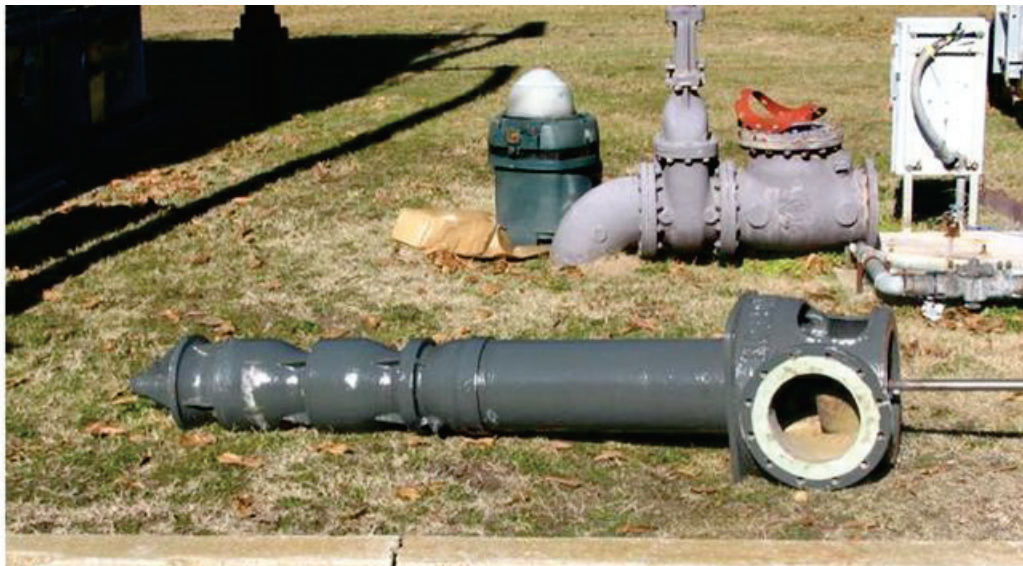
Figure 9. Pump 3, after coating.

Column and bowl sections for pumps 0495803 and 0495804 were abrasive-blasted and recoated. The column and bowl sections of pump 0495803 were coated with Macropoxy 646 Fast Cure Epoxy primer, followed by Tile-Clad High Solids Epoxy-Polyamide topcoat. The coated, refurbished pump is shown in Figure 9, and the reinstallation of this pump is presented in Figure 10.

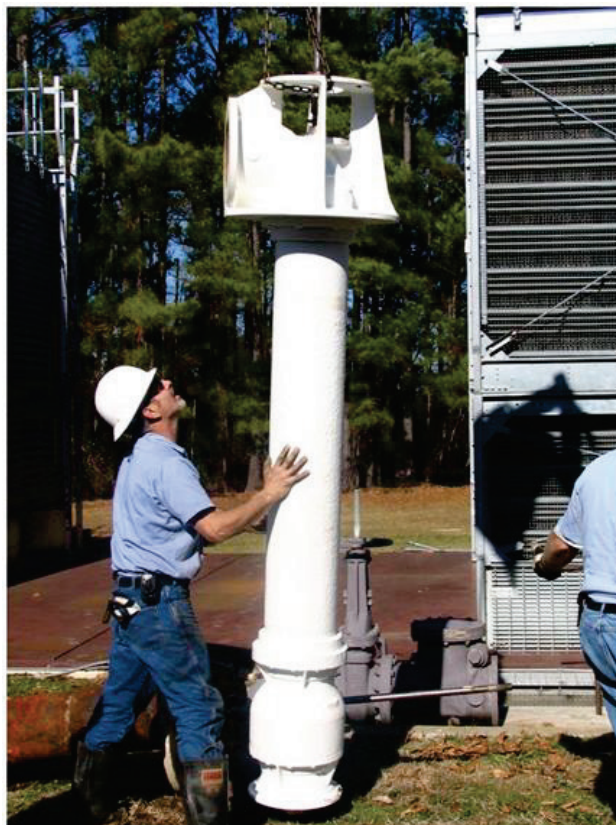
Figure 11. Pump 4 being reinstalled.

Column and bowl sections of pump 0495804 were coated with System No. 21-A-Z, which consisted of MIL-DTL-24441/19B (Formula 159) zinc-rich epoxy primer followed by MIL-DTL-24441 Formula 151 topcoat. Figure 11 shows the condition of this coated, refurbished pump as it is being reinstalled.

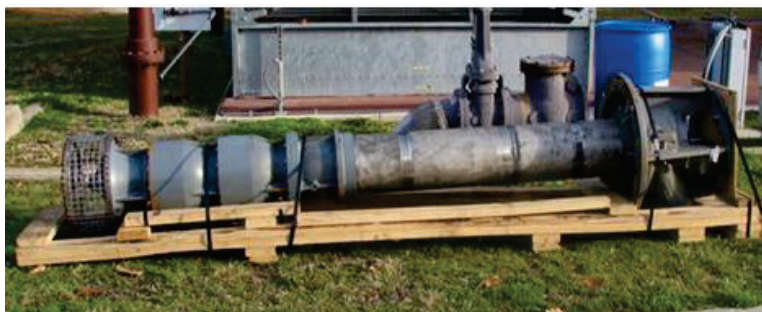
Figure 12. New pump 5 incorporating 316 stainless steel housing.

The fifth pump was replaced with an entirely new pump incorporating a corrosion-resistant alloy, 316 stainless steel. As stated previously, only the column section was made of 316 stainless steel; the lower half was cast iron painted by the manufacturer prior to shipment with a cycloaliphatic amine epoxy, Carboguard 890. Based on the information provided from the manufacturer, no topcoat was applied. The new pump is shown in Figure 12, and its installation is depicted in Figure 13.

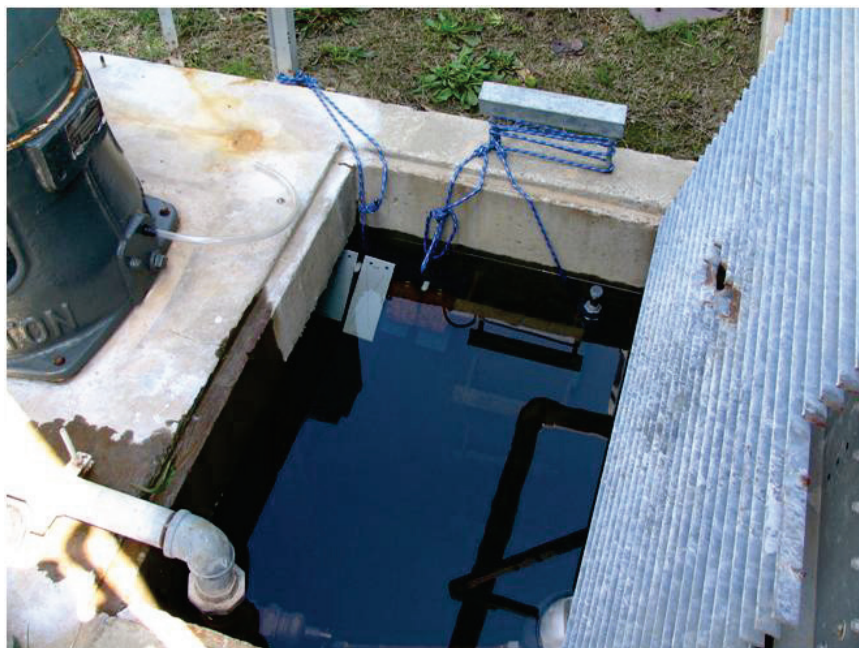
Figure 14. Test panel rack suspended from far edge of sump.

Eighteen test panels and three test racks were prepared. Each of the three test racks contained two panels for each of the two coating systems (one panel scribed, the other unscribed), two additional panels with primer only (Macropoxy 646, representative of the painted control pump), and two bare panels. In each of the three test sumps, one rack was suspended by means of a rope. A test rack suspended in the sump is shown in Figure 14.

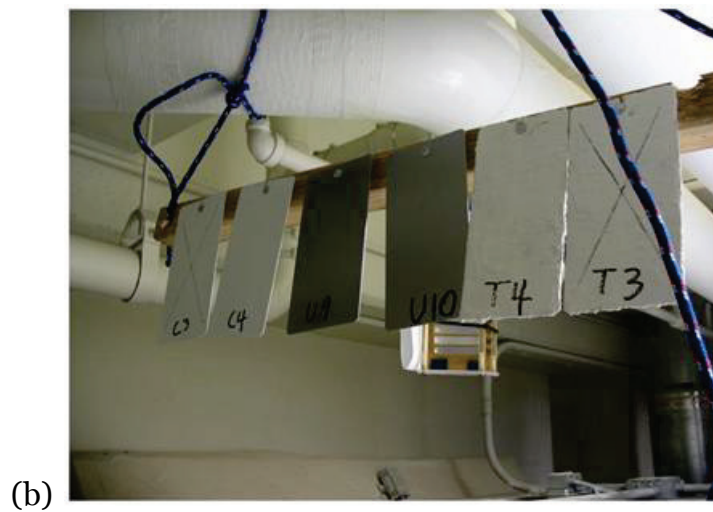
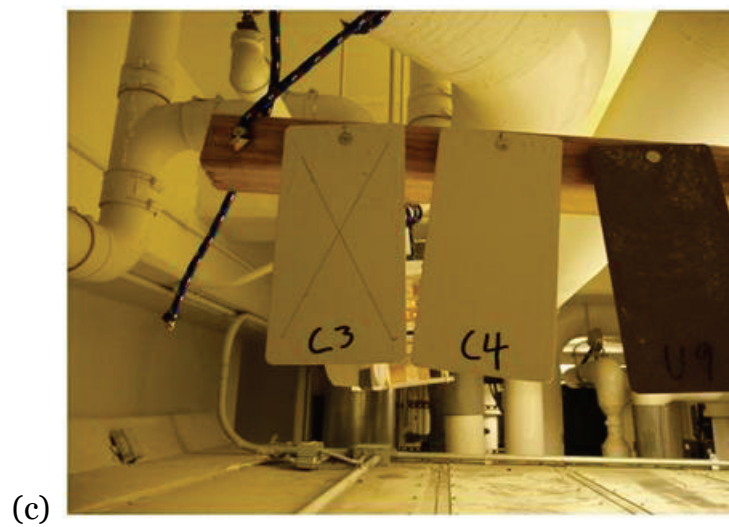
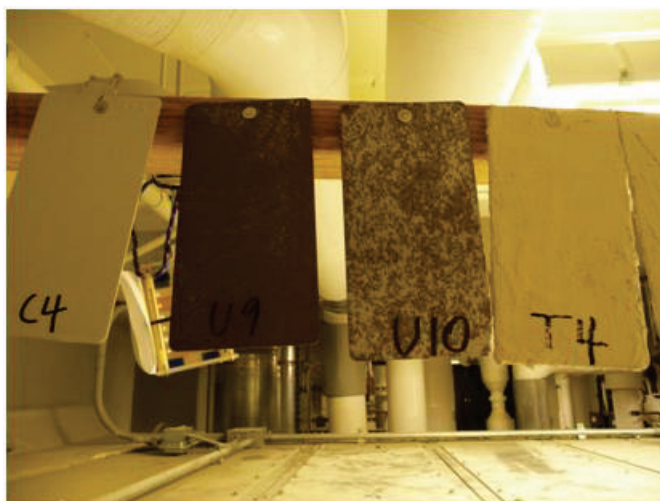
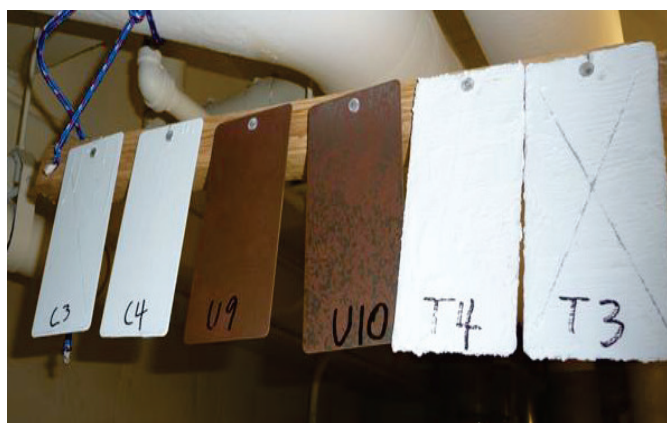
In Mechanical Room A, neither the TC Ceramic-coated coupons nor the Corothane-coated coupons demonstrated any signs of corrosion during the entire evaluation period. All panels received D1654 ratings of 10 throughout the evaluation period (Table 8). Figure 16 demonstrates the pristine nature of the Corothane-coated coupons (C3 and C4) and the TC Ceramic coated coupons (T3 and T4) in Mechanical Room A at 3, 6, 9, 12, and 30 month intervals. As a means of comparison, severe corrosion can be seen on the two uncoated panels (U9 and U10) from the ninth month and onward.

Figure 16. Test coupons in Mechanical Room A exposures at 3 months (a), 6 months (b), 9 months (c), 12 months (d), and 30 months (e).

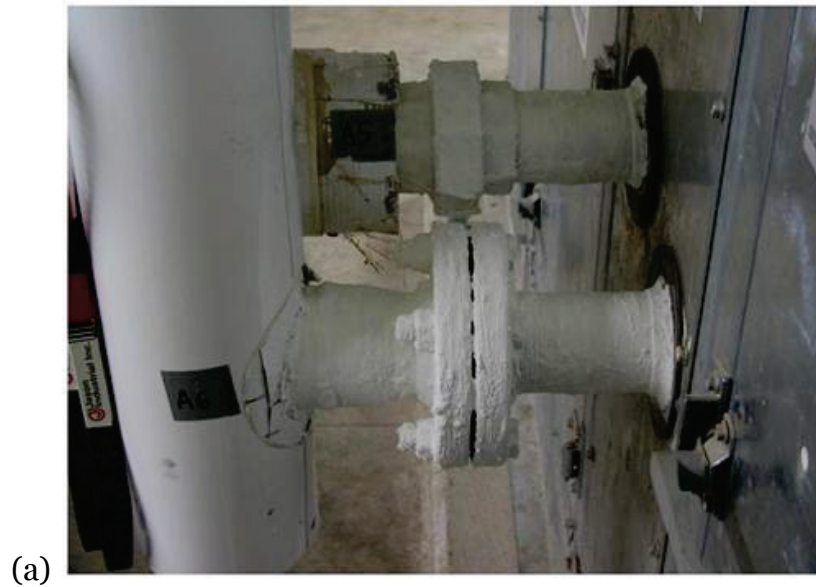
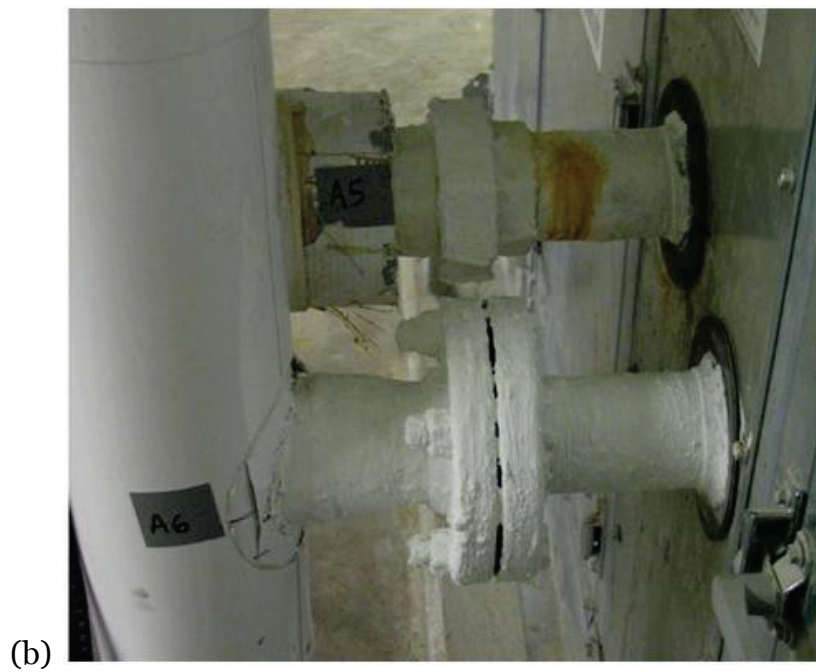
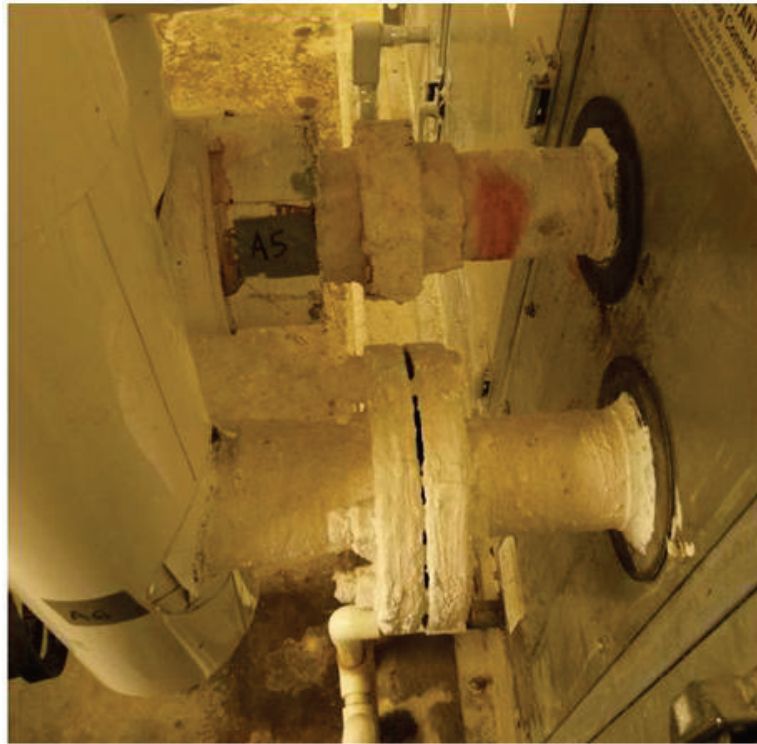
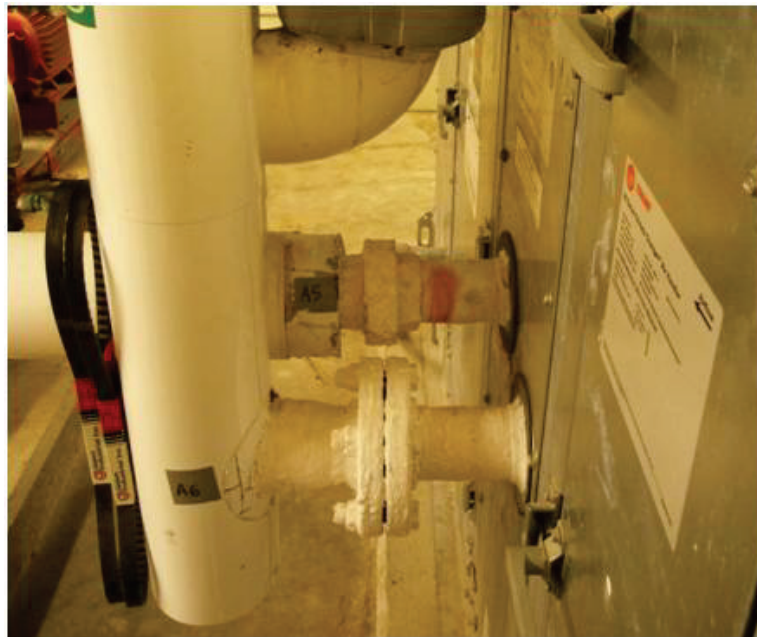
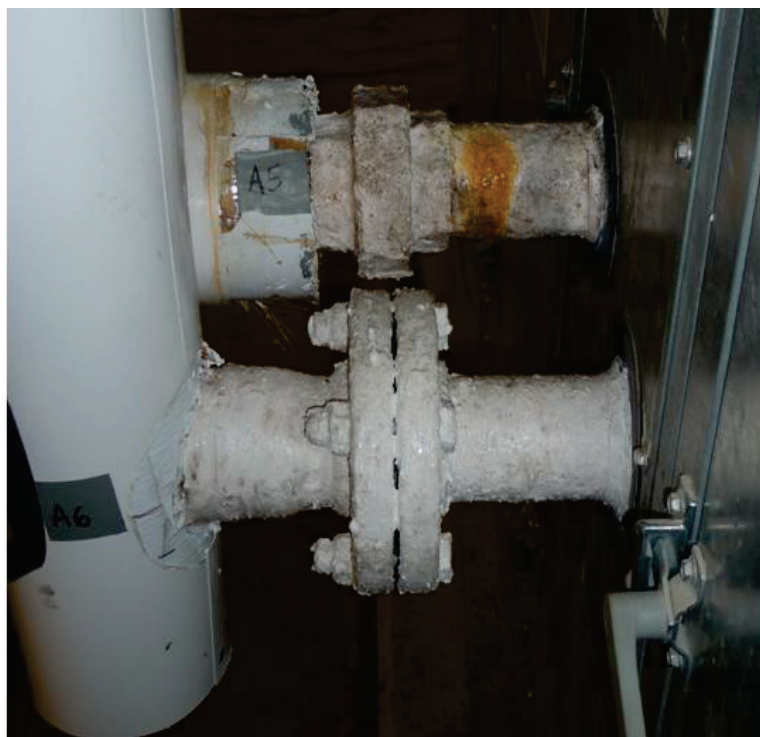
Minimal differences in coating performance were also seen on the coated pipe components in Mechanical Room A. Corrosion was observed only in special cases. For example, two cold-water-line fittings in very close proximity that were coated with TC Ceramic (designated A5 and A6) behaved differently: A5 exhibited rusty discoloration by 3 months of exposure, while A6 did not corrode at all up to 12 months. The rusty discoloration observed on A5 was caused by rusty water dripping down from another fitting. Otherwise, performance was very similar to that of A6, which had nothing dripping down onto it. By June 2010, the wet, rough surface of both fittings had accumulated mold on their rough, damp exteriors, but this did not influence corrosion ratings. These fittings were damp during this evaluation (Figure 18e), with considerable condensation (but not enough to drip or cause significant corrosion). The insulating properties of the TC Ceramic coating were apparently unable to impede condensation on these fittings. The performance of these fittings (A5 is in the rear, A6 is in front) throughout the evaluation period is presented in Figure 17.

Figure 17. Two cold water line fittings coated with TC Ceramic in Mechanical Room A exposures at 3 months (a), 6 months (b), 9 months (c), 12 months (d), and 30 months (e).

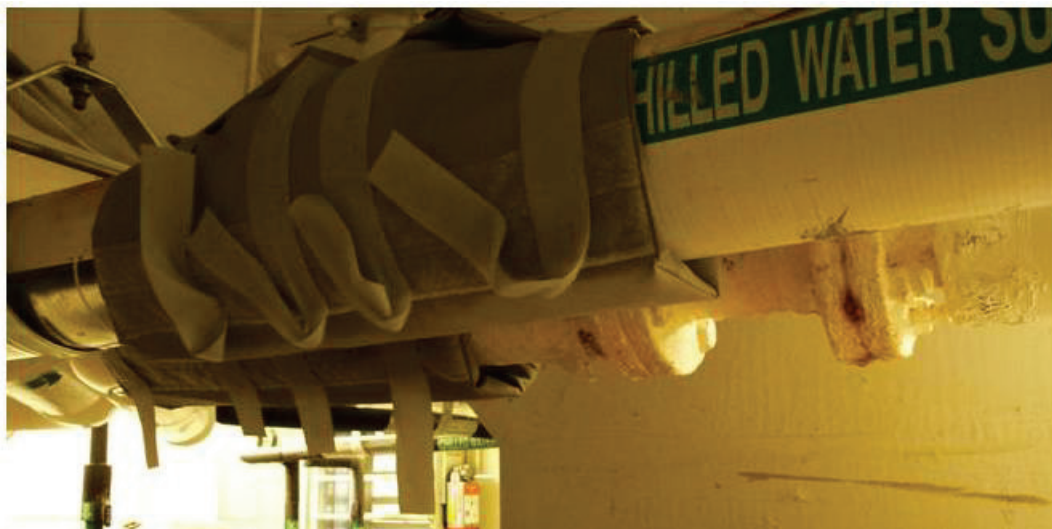
Figure 22. SpeedWrap on fittings, Mechanical Room A, 9 months exposure.

It was noted that the SpeedWrap insulation was difficult to attach to the lines. The team worked with the manufacturer to custom-fit pieces to specific joints, but the resulting fit was still loose and evidently not effective in controlling corrosion. Water was observed accumulating in wrapped portions of the line to the extent that it dripped out the ends of the insulation. Figure 22 shows two loosely wrapped fittings at 9 months exposure.

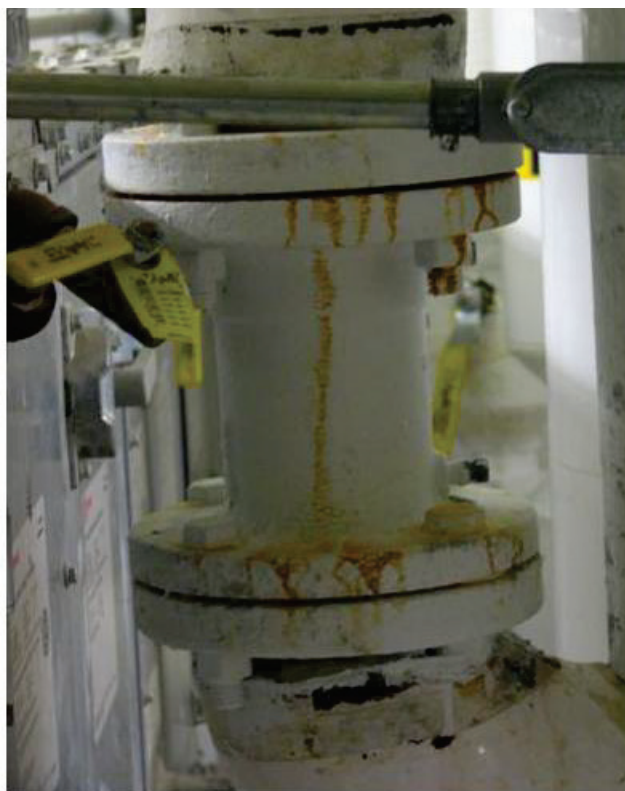
Figure 23. Condition of fitting after removal of SpeedWrap, Mechanical Room A, 12 months exposure.

When the insulation was removed after 12 months, a moderate degree of corrosion was observed (Figure 23). The reduced corrosion was probably attributable the Corothane coating. Most of the corrosion on the union joint appeared at the gap where paint could not be applied evenly.

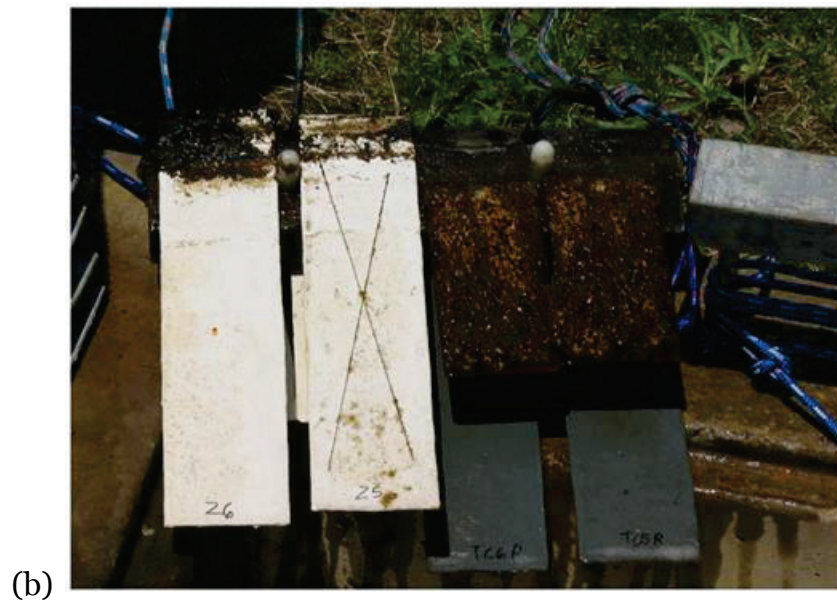
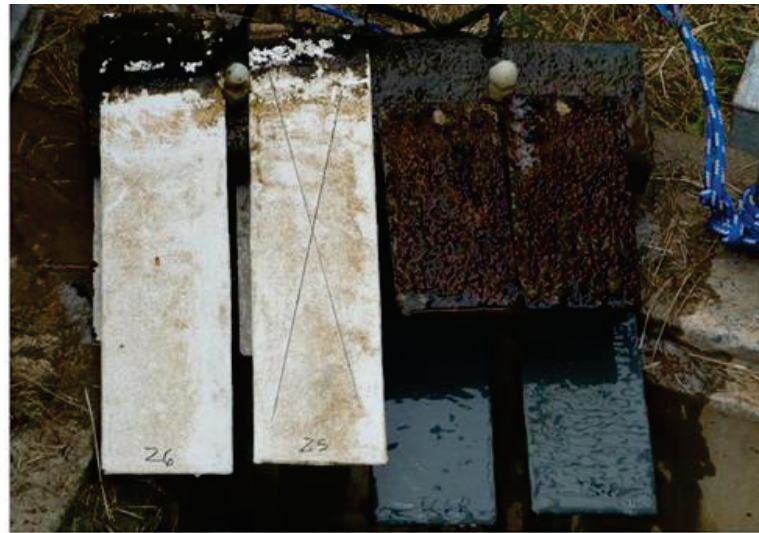
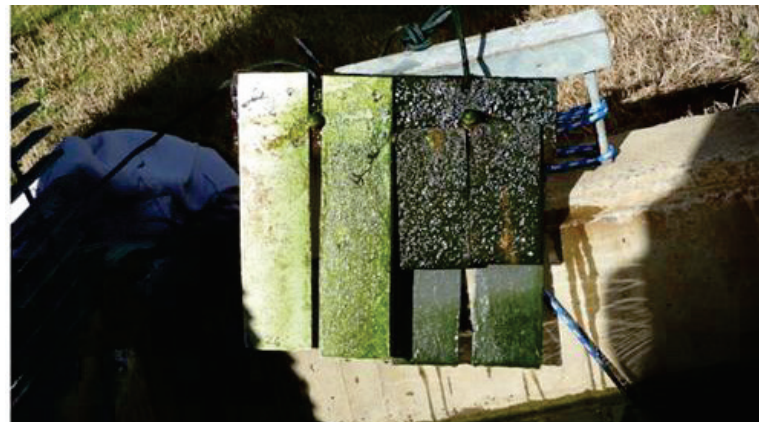
As indicated in the table, the System 21-A-Z candidate clearly outperformed the Macropoxy candidate. This performance was observed on both panels and pump components. While a great deal of dirt and algae was accumulated on the panels, the integrity of the coating could still be observed and recorded. The performance of the System 21-A-Z coated panels and the uncoated panels in pump 3 throughout the evaluation period is presented in Figure 24; the performance of the Macropoxy-coated panels and the primer-only panels are presented in Figure 25.

Figure 24. System 21-A-Z and uncoated panels for pump 3 exposures at 3 months (a), 6 months (b), 9 months (c), 12 months (d), and 30 months (e).

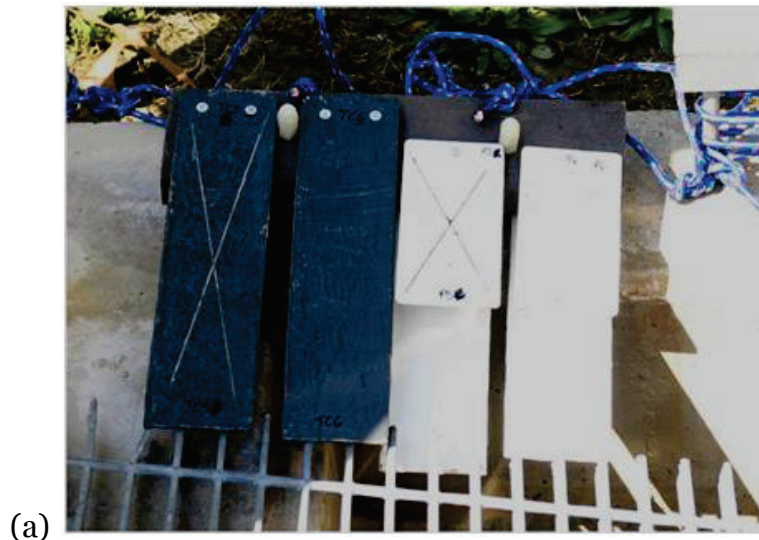
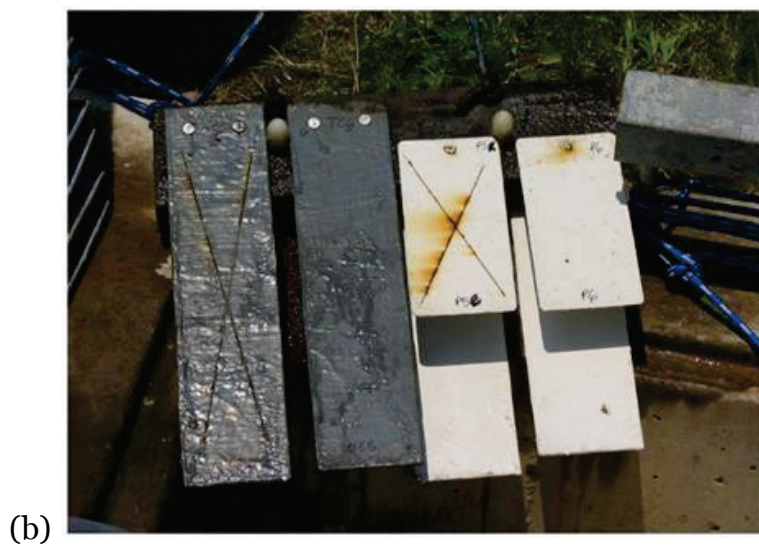
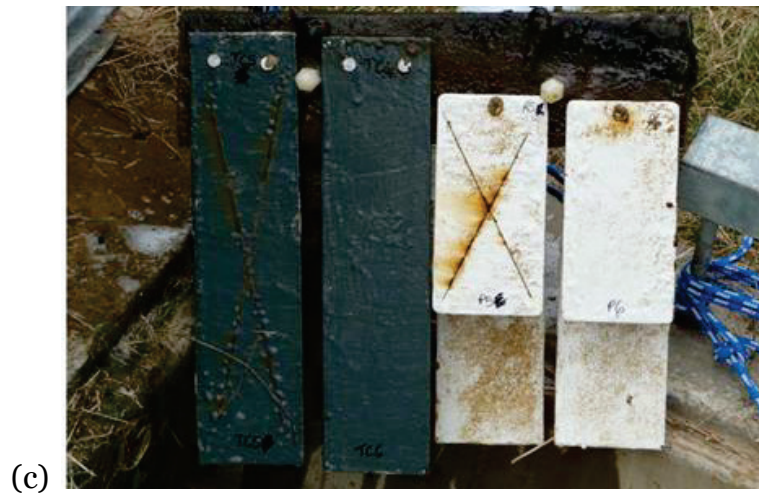
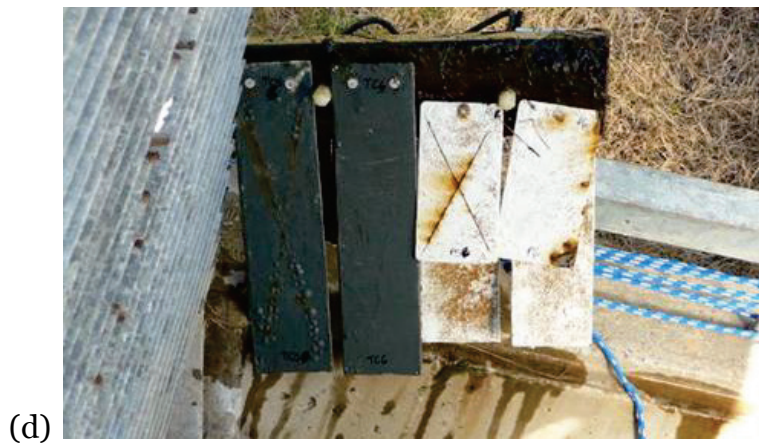
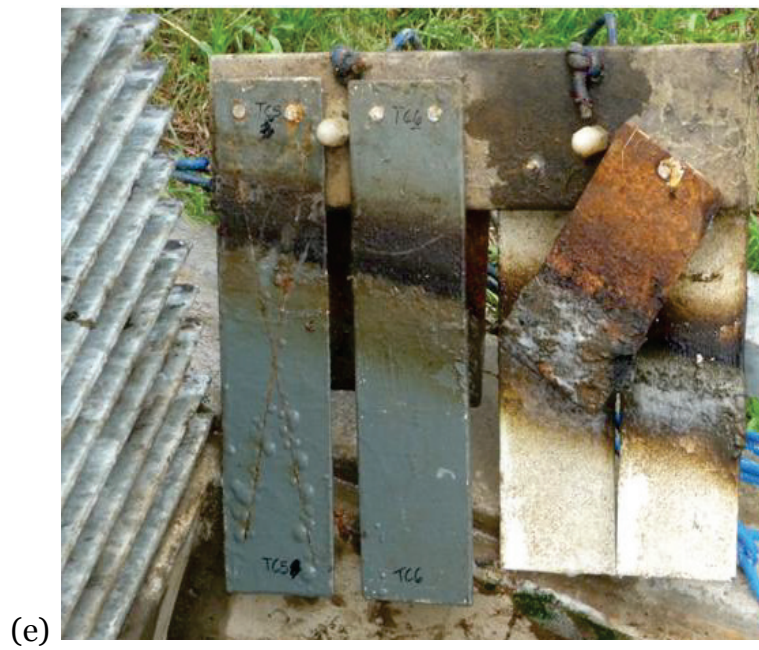
Figure 25. Macropoxy primer-topcoat and primer-only panels for pump 3 exposures at 3 months (a), 6 months (b), 9 months (c), 12 months (d), and 30 months (e).

It is noted that the Macropoxy primer-only panels performed similarly to the Macropoxy primer-topcoat system panels for the first 12 months, which seemed to demonstrate that the application of the topcoat did not provide a noteworthy degree of additional protection.

However, evaluations after an additional 18 months revealed a sharp difference between the two types of Macropoxy specimens: the coatings on the primer-only panels had failed completely (see Figure 26e), and one primer-only specimen (the scribed coupon) had entirely corroded and fallen off the rack; even the uncoated panels (see Figure 25e) were less corroded than the primer-only panels. Hindsight reveals early signs of this performance at 12 months (see Figure 26d), as the unscribed panel had begun peeling early at its lower-right corner. This behavior was also observed on the primer-only panels in pumps 4 and 5, where the primer-only panels had only small scraps of loose coating still in place.

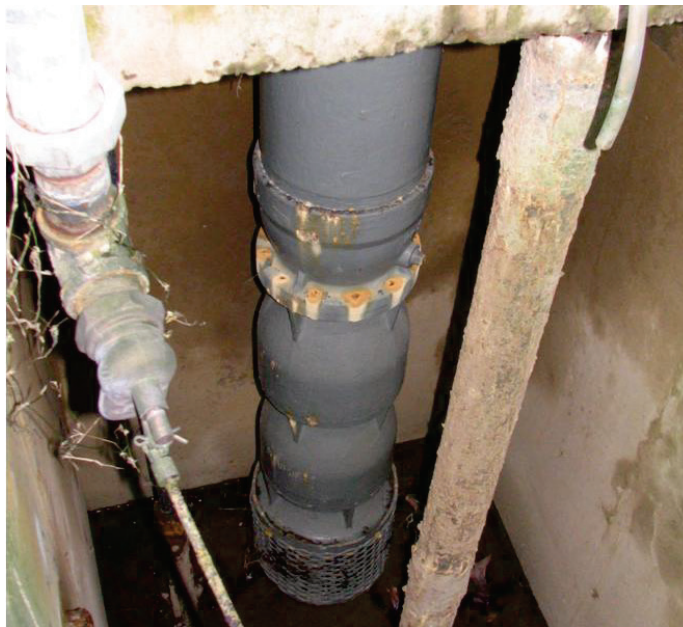
Figure 26. Pump 3 (Macropoxy primer-topcoat), 12 months.

The condition of the pumps after 12 months of exposure is presented in Figure 26 through Figure 28. The pump sumps were filled with water and could not be evaluated until January 2009. The results shown in the photos below echo those of the coupons, in that the System 21-A-Z coating outperformed the Macropoxy system. The stainless steel upper housing performed well through January 2009, but the cast iron pump bowls (painted with Carboguard 890) showed extensive corrosion, as seen in Figure 28.

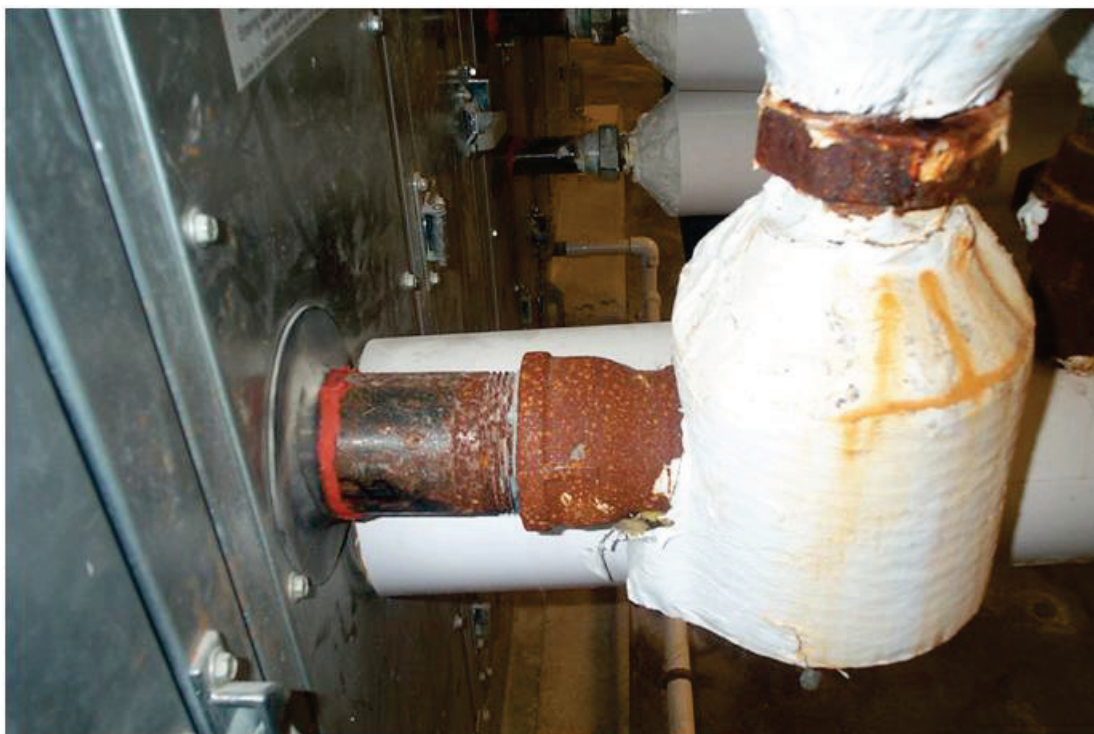
a. Mechanical Rooms: Steel piping in mechanical rooms with high humidity will readily corrode unless appropriately protected. Accelerated corrosion of exposed union joints in the mechanical rooms at the newly constructed 16th Military Police Barracks at Fort Bragg is a prime example of such corrosion (Fig. 1). The environmental conditions within the mechanical rooms have also resulted in a significant amount of condensate building up on the insulation covering the supply lines, with the metal brackets that support them also collecting moisture. Aside from resulting in accelerated corrosion, there is concern about the potential for organic growth (e.g., mold) under these conditions.

Figure A1. Corroding steel utility piping in high-humidity mechanical room at Fort Bragg.

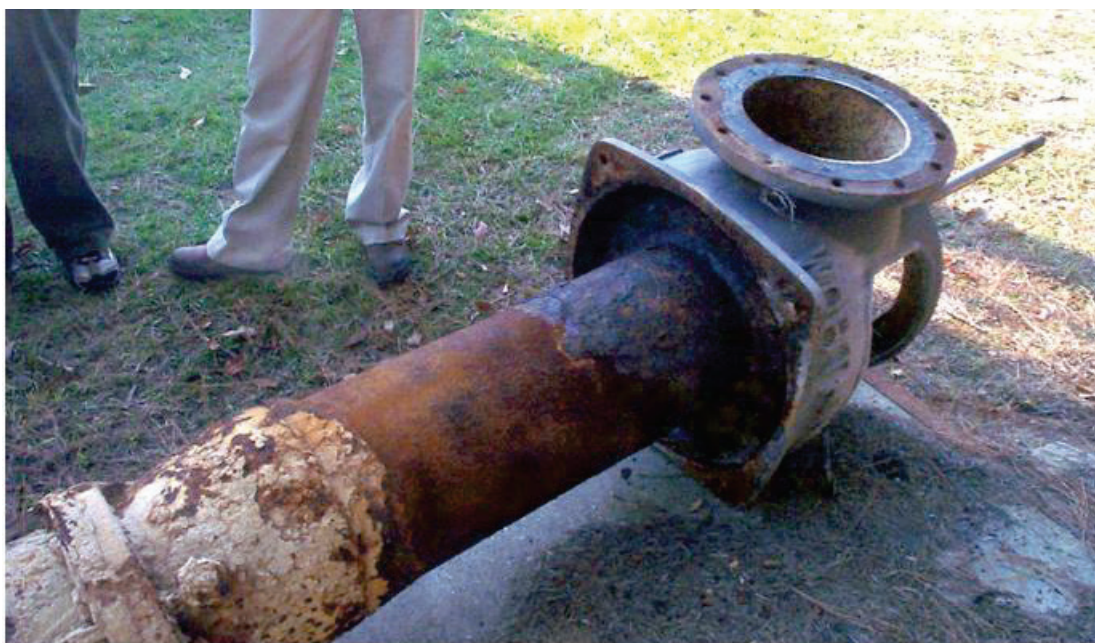
b. Cooling-tower pumps: Accelerated corrosion is also occurring at a relatively new (put on line in 1996) central cooling plant at Fort Bragg. The vertical cooling towers and pumps at this central plant have corroded at an alarming rate, with the pumps reaching total failure due to corrosion within 2-4 years of operation (Fig.

2). These problems can be attributed to the lower housing of the pumps being made of mild steel and exposed to highly oxygenated, turbulent water which effectively consumes the metal, resulting in extensive pitting and flaking of the steel. Ineffective or improper system water treatment may also be contributing to an accelerated rate of corrosion to the pumps.

Figure A2. Corroding pumps bodies at central heating plant at Fort Bragg.
